P R O D U C T I O N M E M O

INSTRUMENT: 8566A SPECTRUM ANALYZER

SUBJECT: KEYBOARD SWITCH FAILURES
(FLYING SPRING SYNDROME)

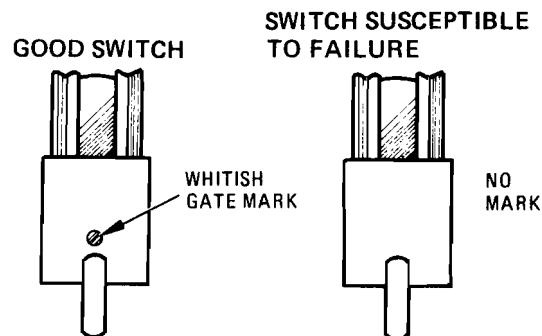
The 85660A RF Section and 85662A IF Display Section Keyboard Assemblies use several pushbutton front-panel switches, HP P/N 5060-9436. Some problems with these front-panel switches exhibiting a "fly-away spring" failure occurred recently. 8566A Spectrum Analyzers shipped between August 1, 1981 and December 10, 1981 are likely to contain front-panel switches that are susceptible to this failure. The failure occurs only when the instrument has been subjected to low temperatures (below -10 degrees C) and the switches are then actuated at this low temperature.

Not all switches are susceptible to the "fly-away spring" failure. Switches that have a "gate mark" (from the mold) that appears on the red body as a small whitish dot about in the center of the surface opposite the spring (see Figure 1) do not exhibit the "fly-away spring" failure.

Figure 1. Pushbutton Front-Panel Switch, HP P/N 5060-9436

Rebuilt (Blue-Stripe) keyboards have been set up for the RF Section and IF-Display Section; 85660-60183 and 85662-60129 respectively. The rebuilt keyboards include all key caps and all front-panel LEDs. For 85660A RF Sections with serial numbers 2115A00930 through 2140A01140, and 85662A IF-Display Sections with serial numbers 2112A02340 through 2134A02750, follow **PROCEDURE** in this Production Memo. For instruments that do not fall within the above designated serial number ranges, but appear to exhibit the "fly-away spring" failure, contact the 8566A Product Support Engineer before beginning repair.

DO NOT REPLACE KEYBOARDS UNLESS AT LEAST ONE SWITCH HAS FAILED and the failure mode is a "fly-away spring". If one or more switches have failed in this manner, replace both the RF Section Keyboard and the IF-Display Section Keyboard.
